M E M O R A N D U M

SUBJECT: Initial Assessment of 1409 Dundee Road, Elgin, Illinois

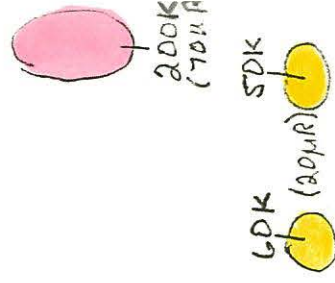
Diagram B

An external survey of the building and yard to the east showed a much more extensive spread of contamination. Referring to diagram B, you will find that the entire east side of the building showed elevated gamma levels with a maximum of 400,000 cpm at surface level. The yard showed eight areas of contamination with a maximum surface level of 200,000 cpm. Micro R levels are also recorded in diagram B and showed a maximum level of 150 micro R at 3 feet. The other areas of the property showed no levels above background. As of yet, the isotope(s) involved have not been determined. I will be running a spectral analysis of soil samples taken from the yard to identify those isotope(s) and their concentrations.

According to Mr. Jadown, the proposed construction of the parking lot would undoubtedly invade the areas of contamination. Building the parking lot would involve stripping the top soil off and creating a negative grade towards the center for a storm sewer. I stressed to Mr. Jadown that we needed to prevent any contamination from leaving the site, if disposal is not required. I stated to Mr. Jadown that my unofficial gut reaction was; that we would need to isolate these areas of contamination, dig them up and stockpile them in the existing parking lot and reduce the volume through sorting to limit the quantity used as backfill. When the trench for the storm sewer is dug, we could then use this material, along with the contaminated drain pipe, to fill in the lower areas of the trench. Because pea gravel is the normal backfill, this would allow a lower pressure pathway for radon and would insure no increased radon levels in the building.
